The Berger Manufacturing Co.
Canton, Ohio

Fire, Water and Load Tests on
Berger's *Metal Lumber* System
(Patented)

Pressed Steel Fireproof Construction

These Tests are designed to produce as near as possible the maximum conditions which prevail in large conflagrations and at the same time provide means of accurately recording the action of the material at all times. ∴ ∴

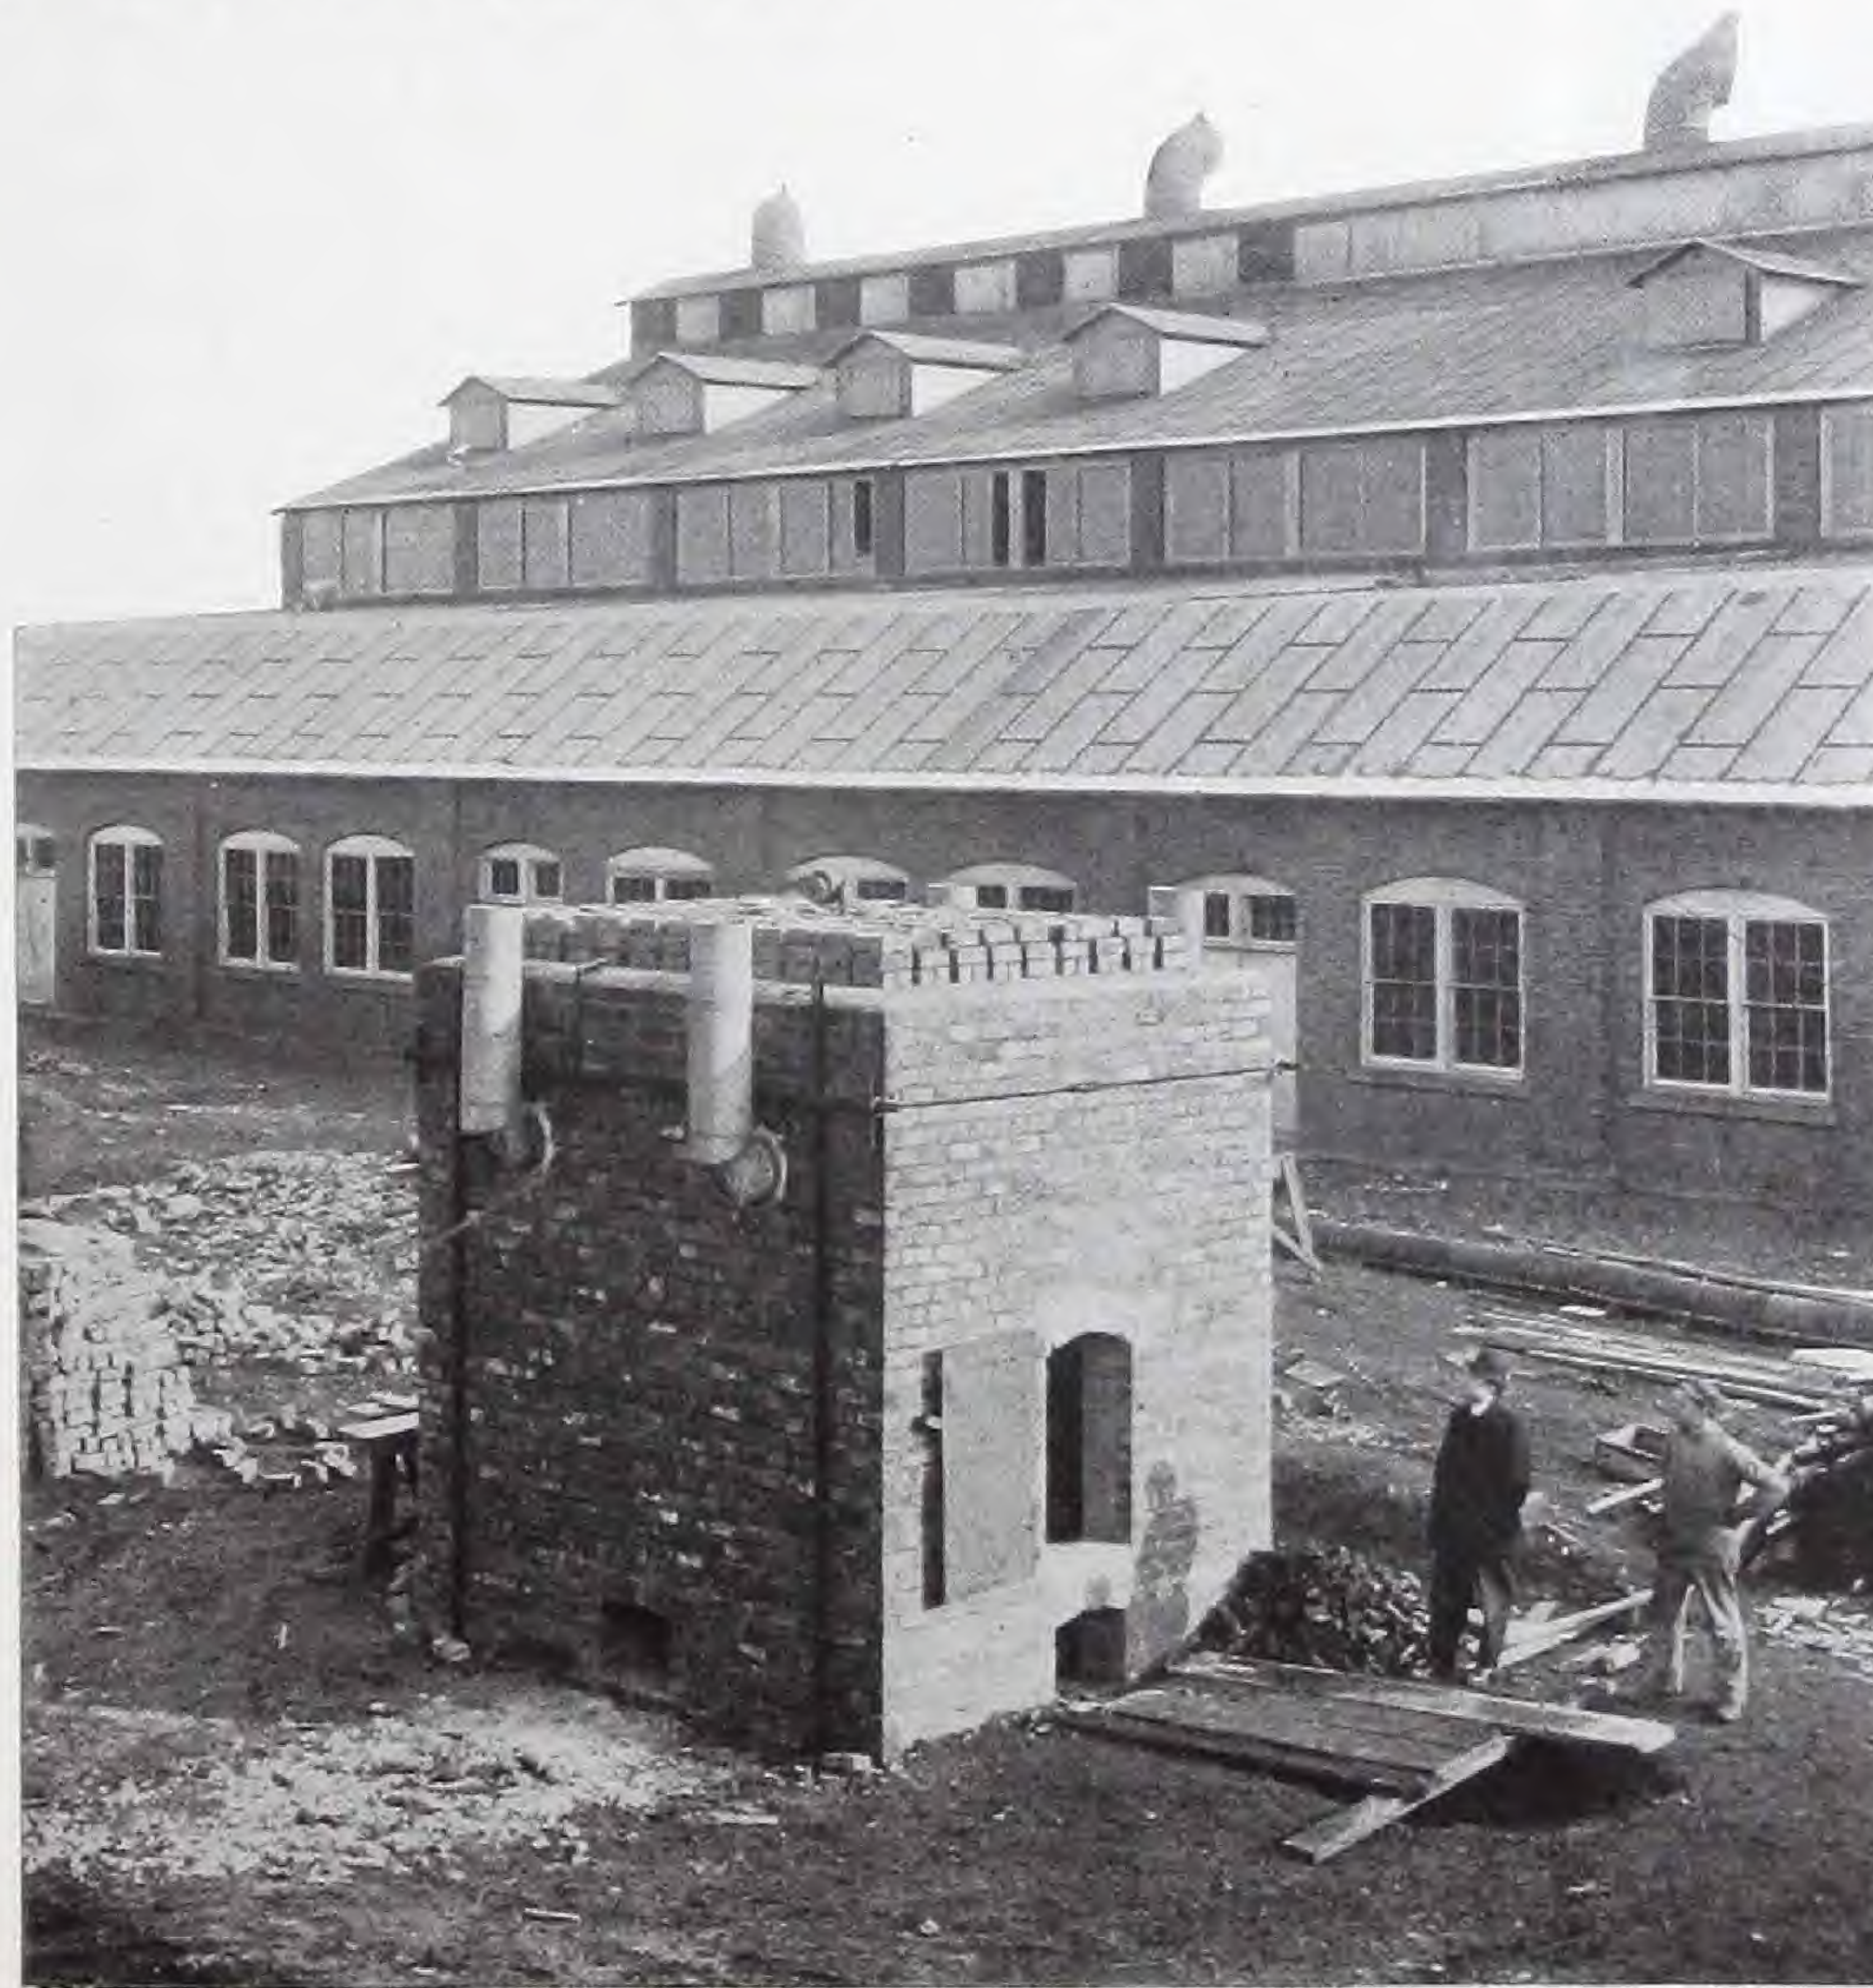
Fire, Load and Water Test on METAL LUMBER System of Fireproof Floor Construction Before Fire was Started. Normal Temperature 32° F.

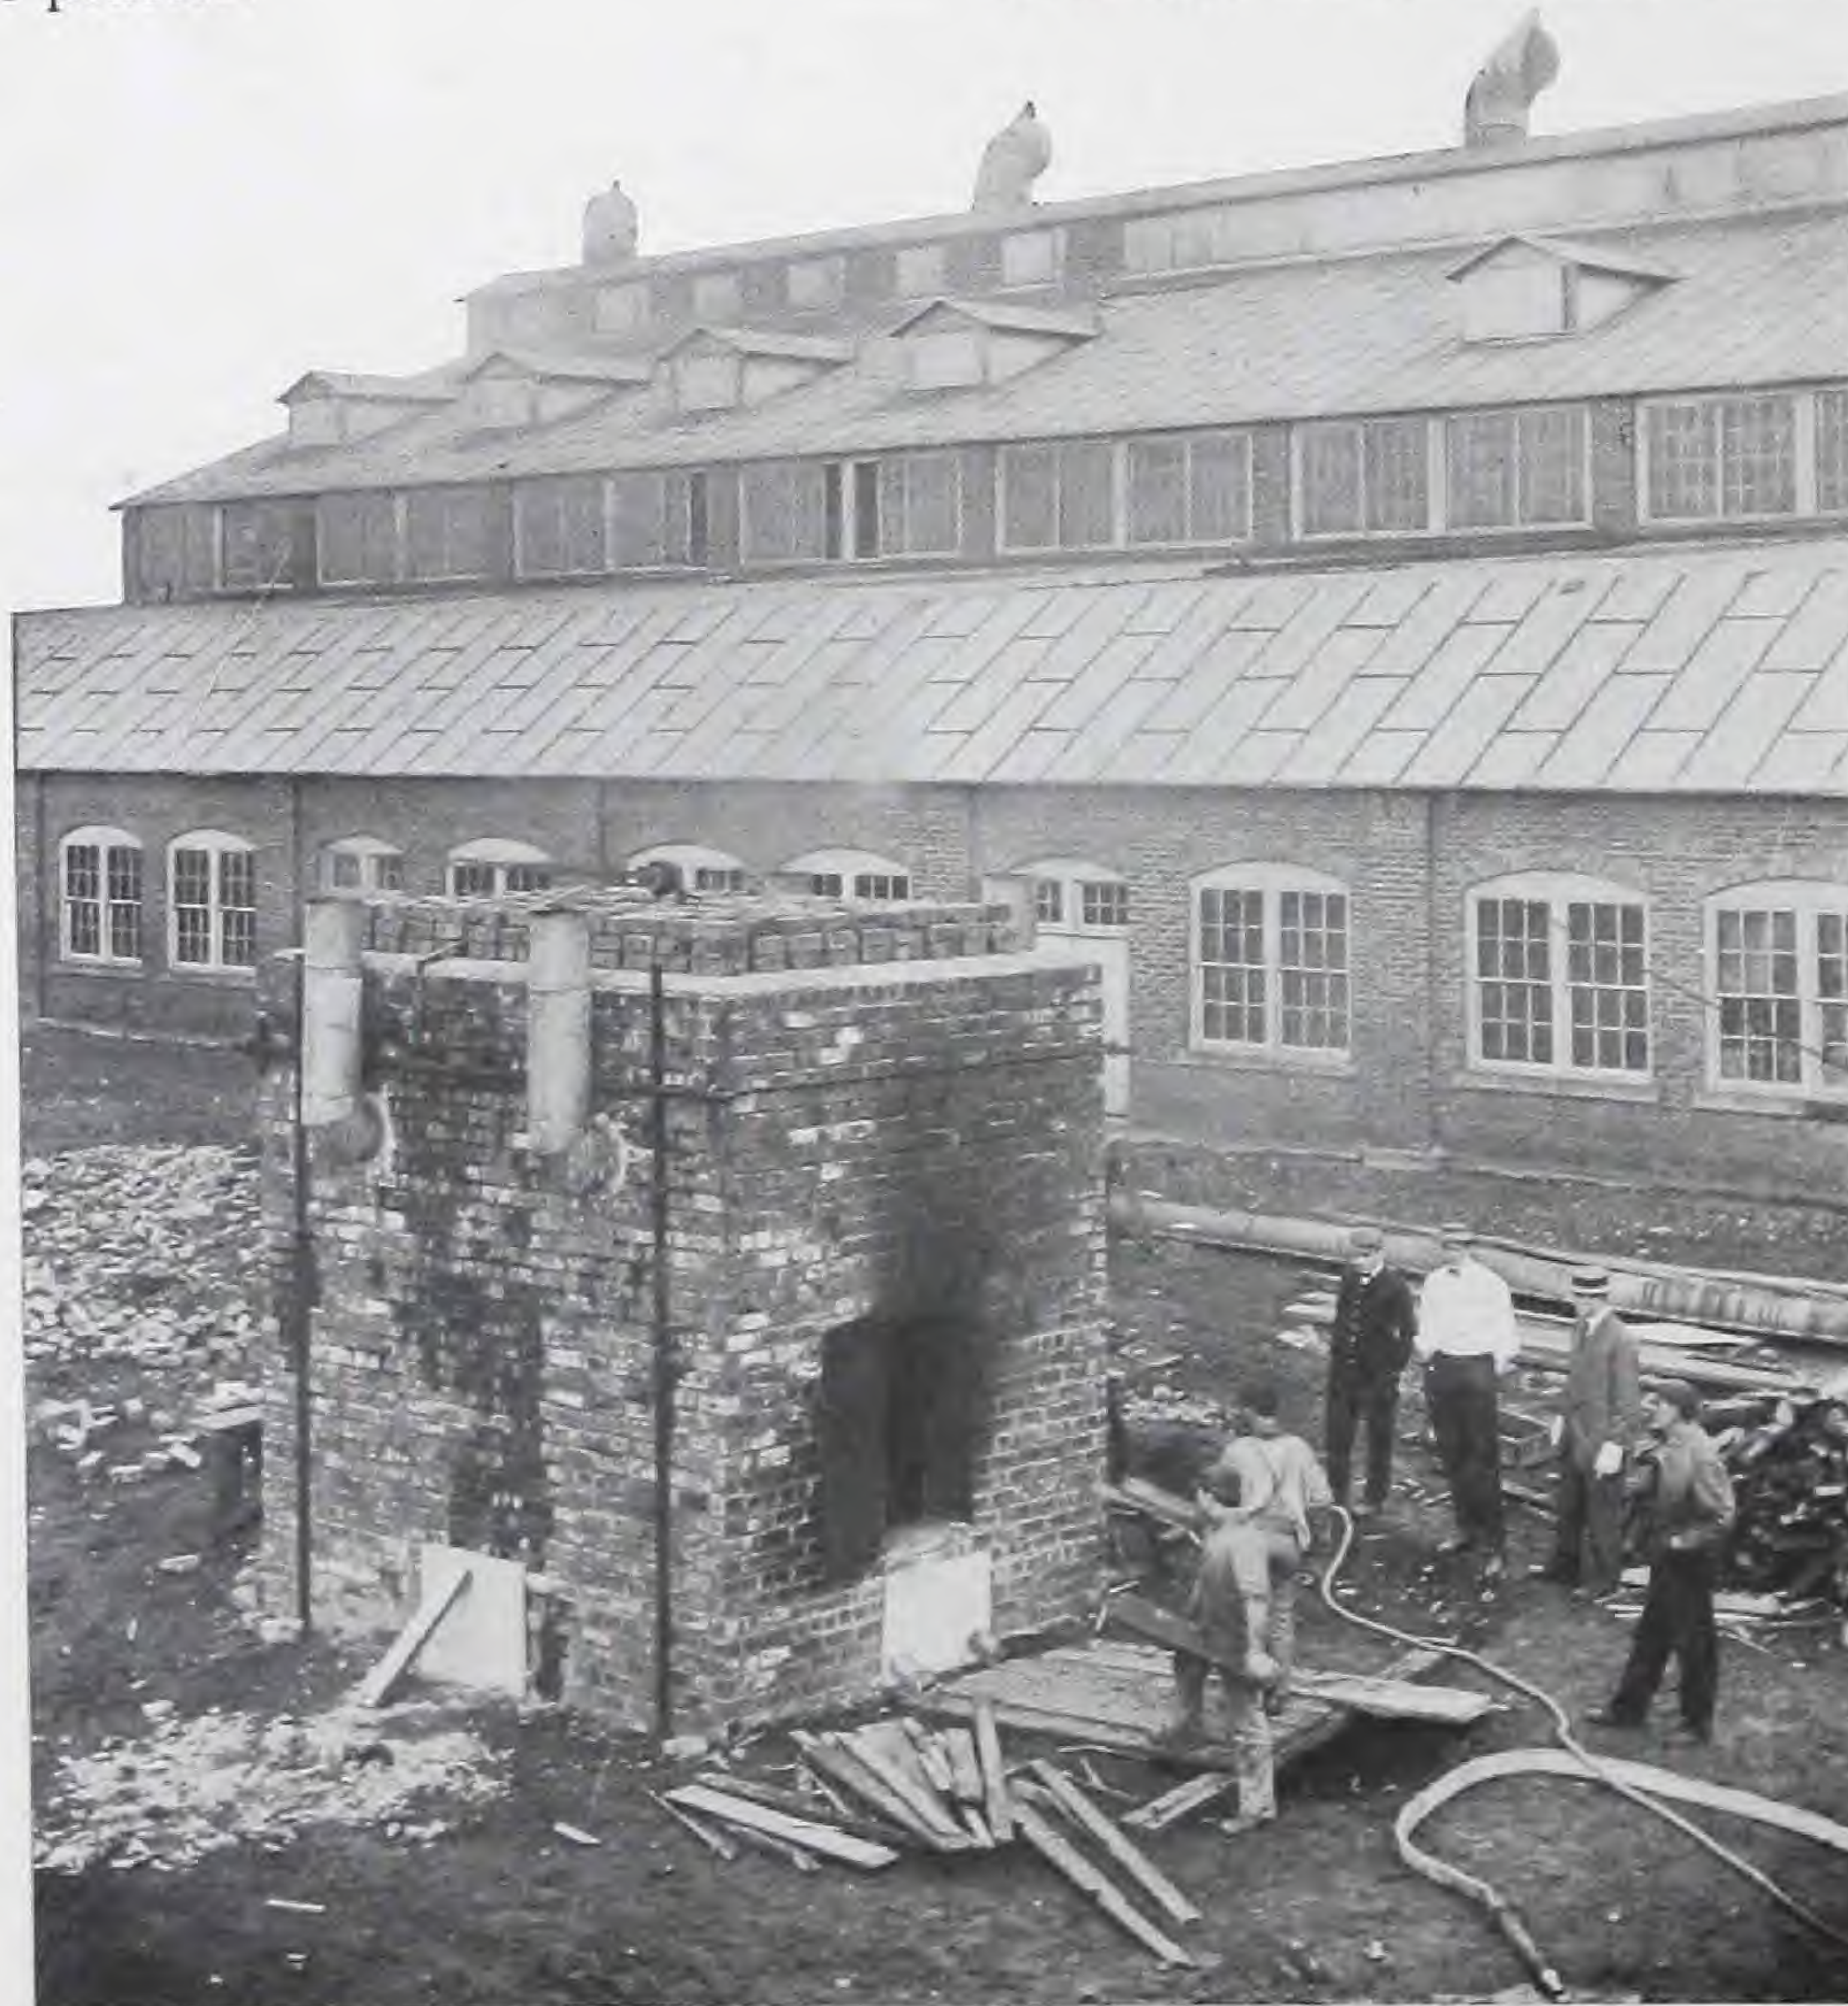
Fire, Load and Water Test on METAL LUMBER System of Fireproof
Floor Construction. Temperature 2190° F., Five Minutes
Before Water was Turned In.

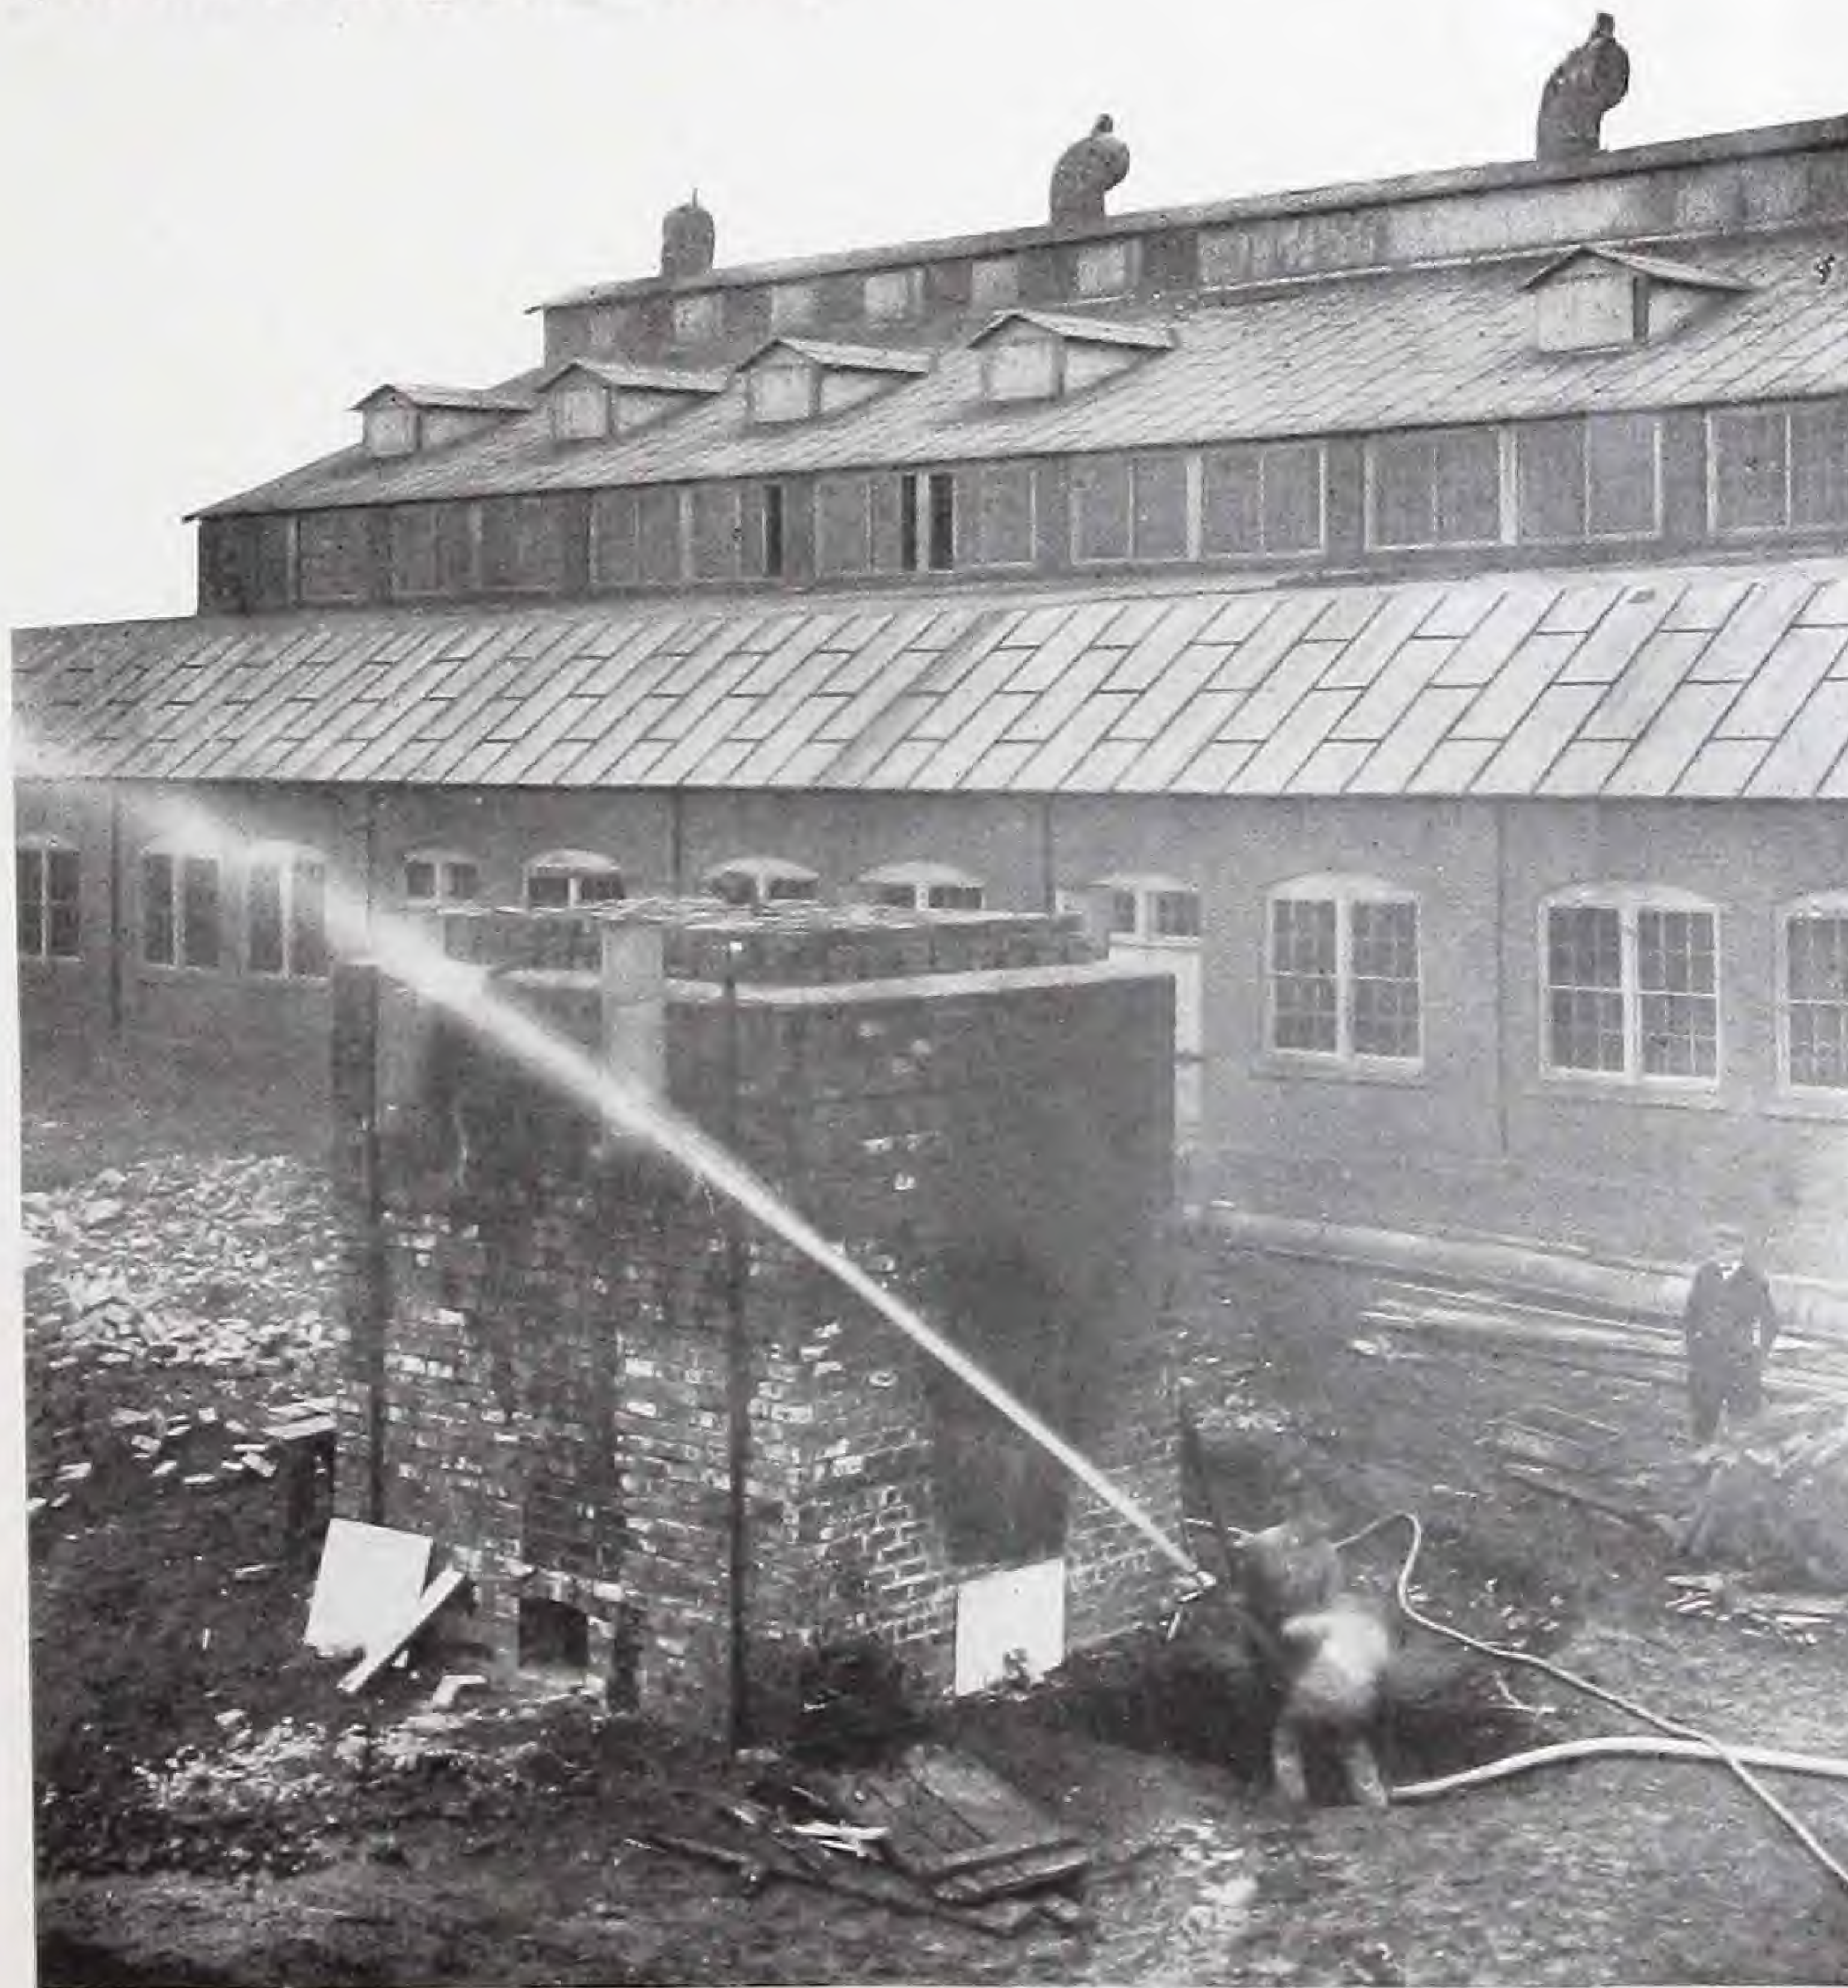
Fire, Load and Water Test on METAL LUMBER System of Fireproof Floor Construction. Temperature 2408° F. Note Water Pressure, 65 lbs. per Square Inch at Hydrant. 1½-inch Diameter Nozzle.

The water was applied through a 2½-inch cotton hose attached to the city water plug, which had a hydrant pressure of 65 pounds per square inch. To the hose was attached a regulation nozzle 1½ inches in diameter and by referring to the picture below you will note the force existing when water was turned in.

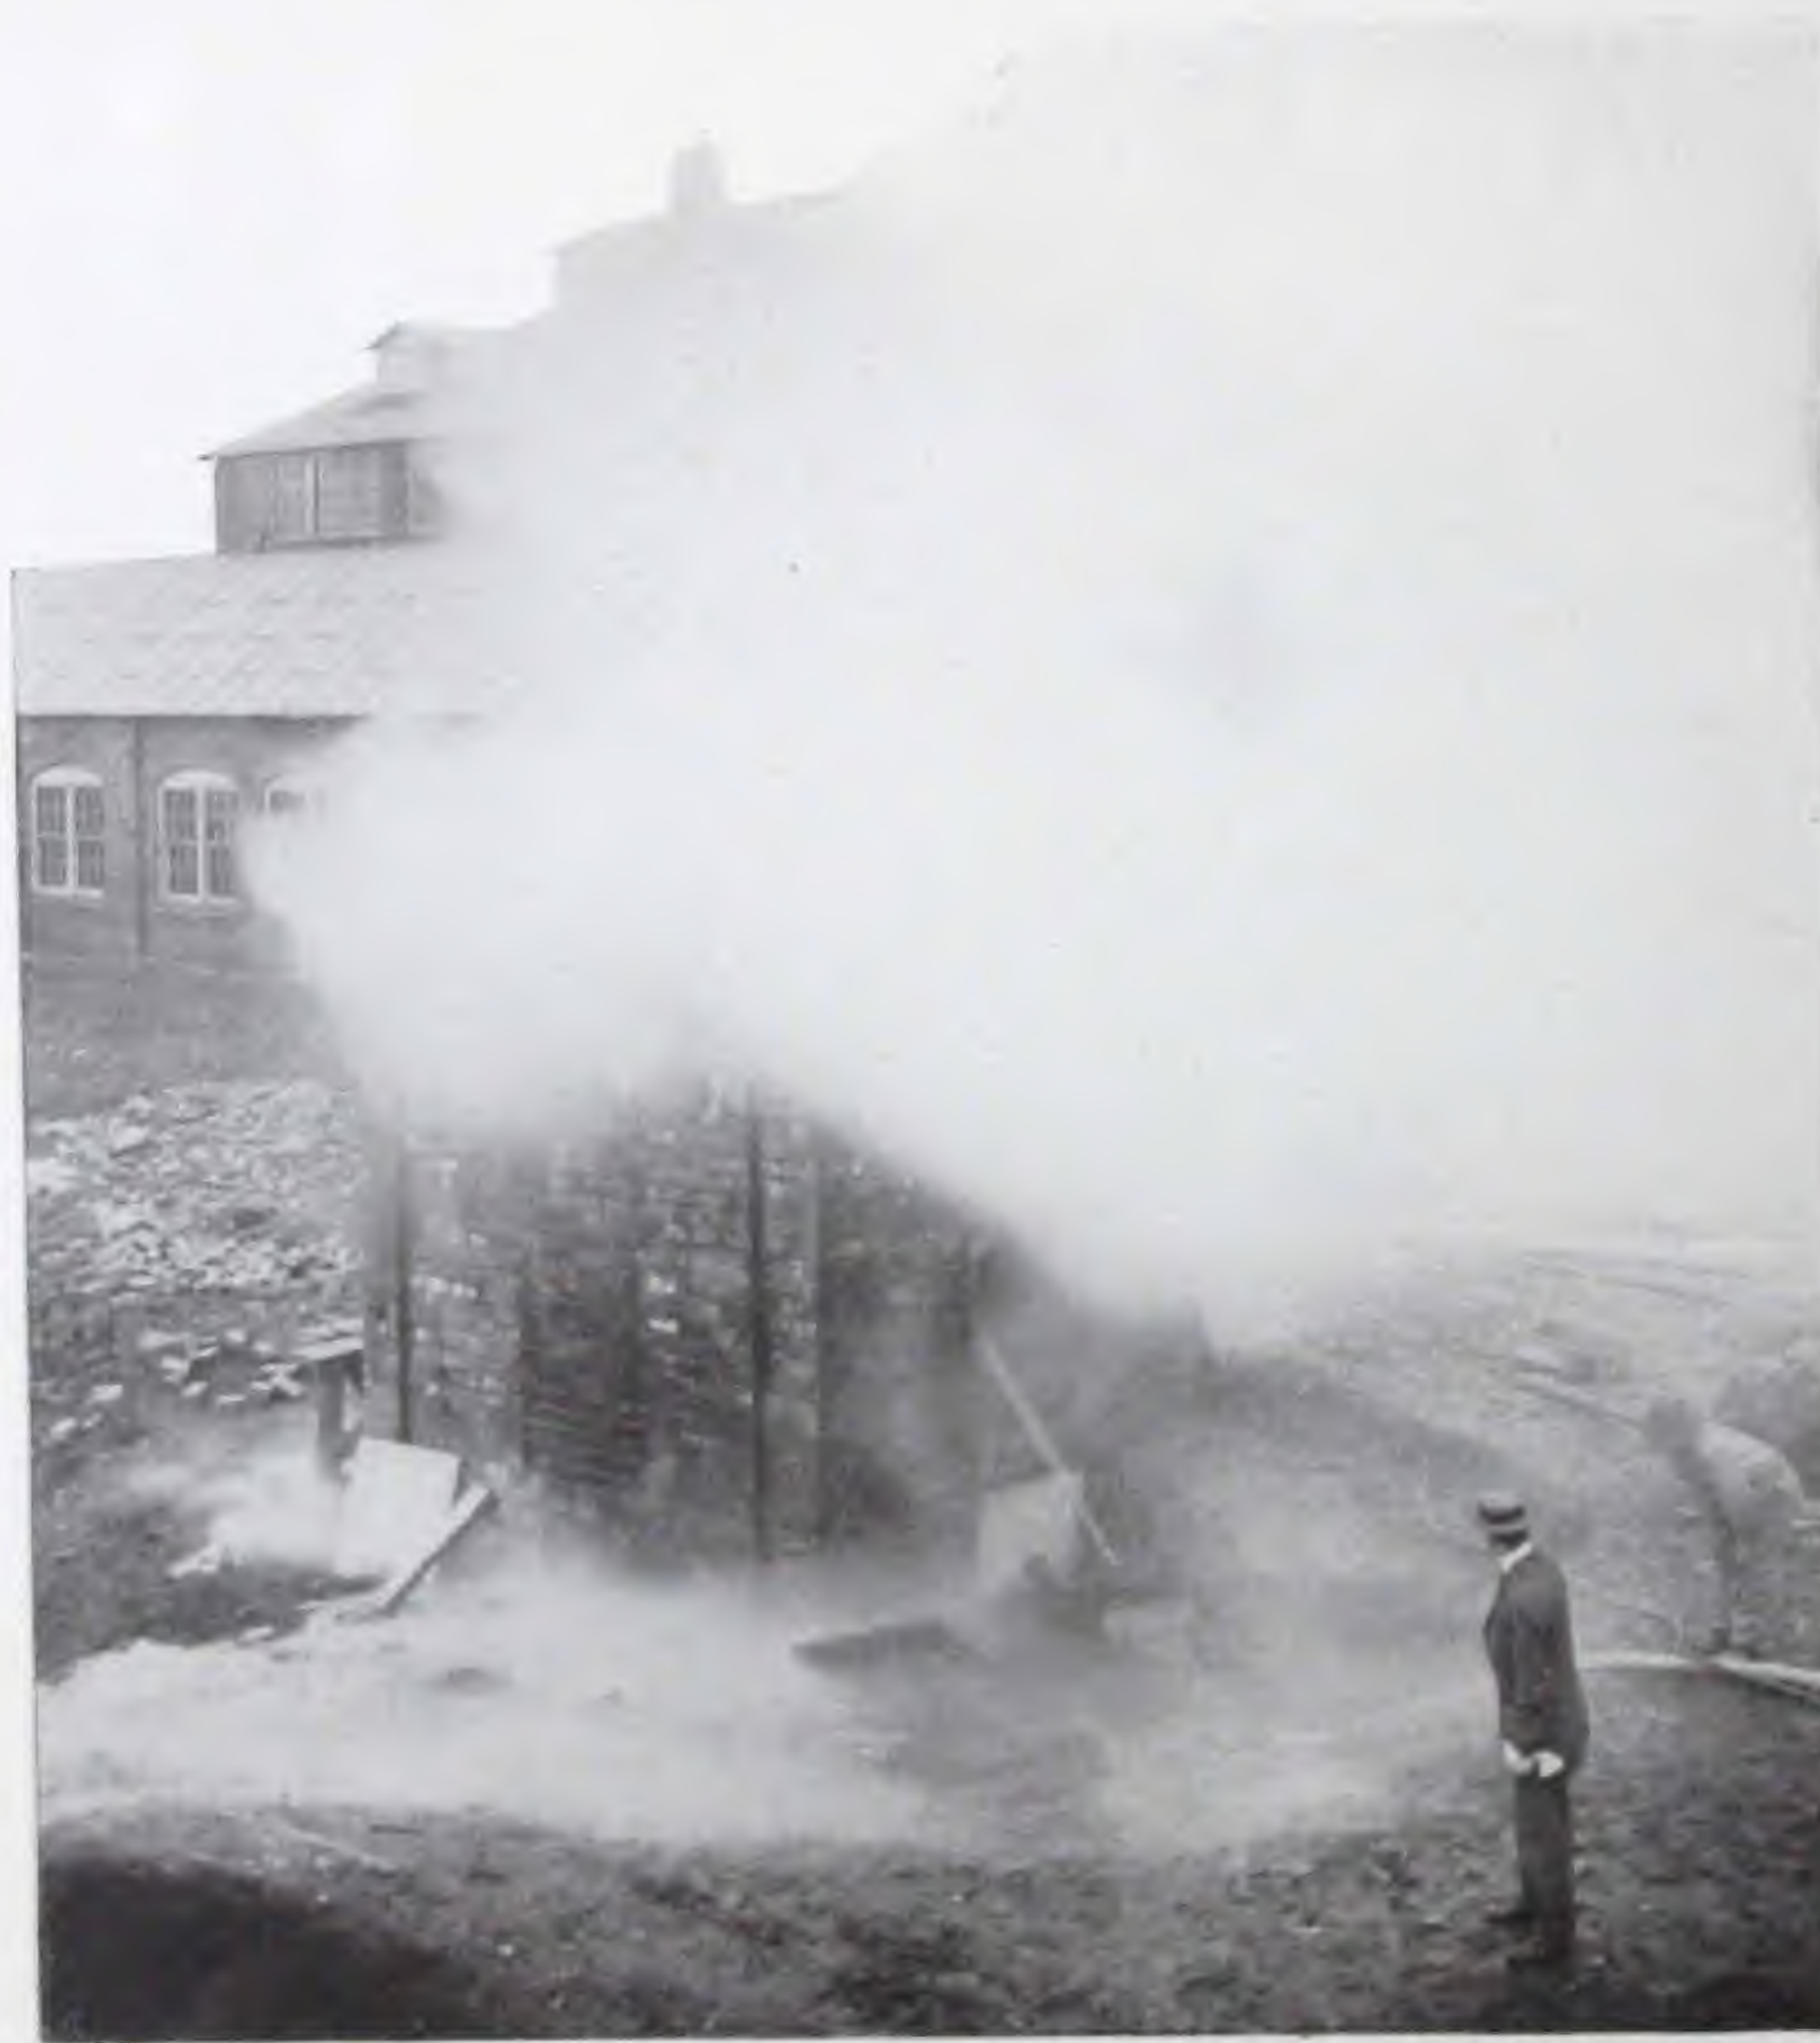
Fire, Load and Water Test on METAL LUMBER System of Fireproof Floor Construction. Water Directed on the Ceiling.

Where the stream of water was applied to the ceiling and allowed to be directed at one spot for a considerable length of time, the plaster was removed, exposing an area of approximately 2 square feet of Expanded Metal Lath. At other points of the ceiling

where it was applied at frequent intervals the second coat of plaster fell off in some cases; but the scratch coat remained wholly intact with the lath completely encased, and on only about one-third of the furnace was the plaster removed at all. In the other two-thirds

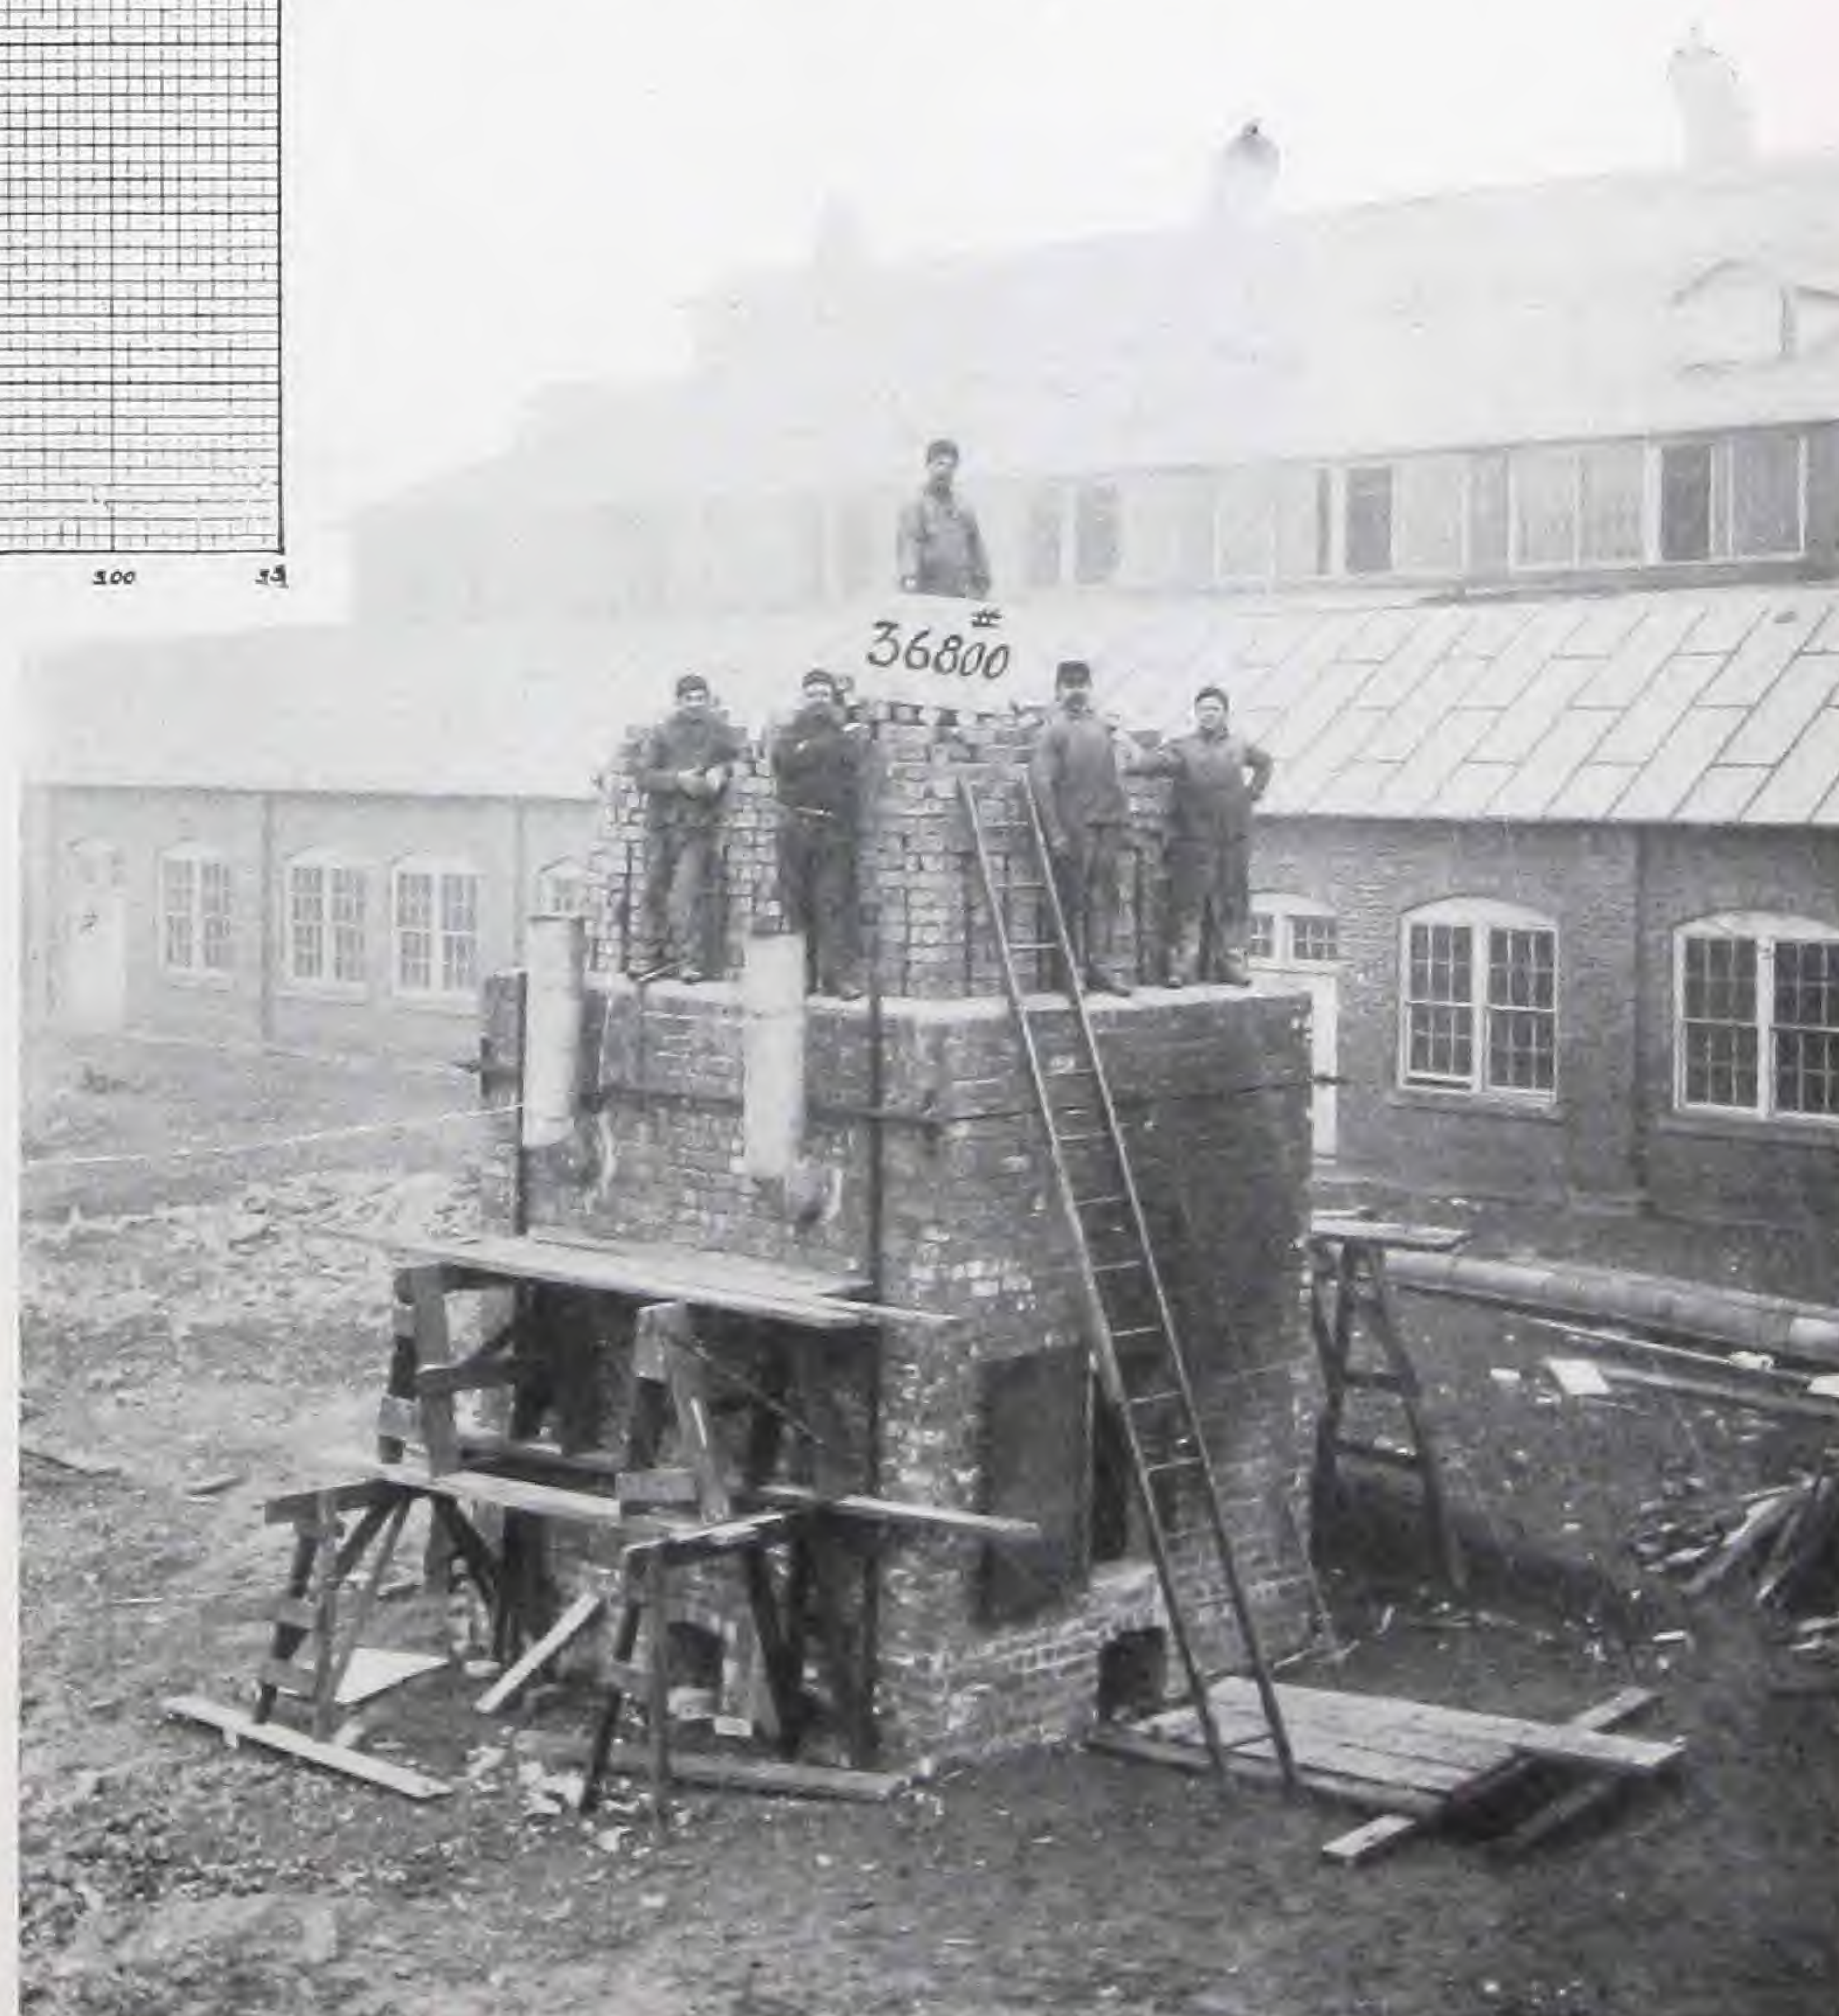
Fire, Load and Water Test on METAL LUMBER System of Fireproof Floor Construction. Load Test Next Day, 480 Pounds per Square Foot. 9/64-inch Deflection.

On the following day the slab was loaded to 480 pounds per square foot, or 6.4 times the required live

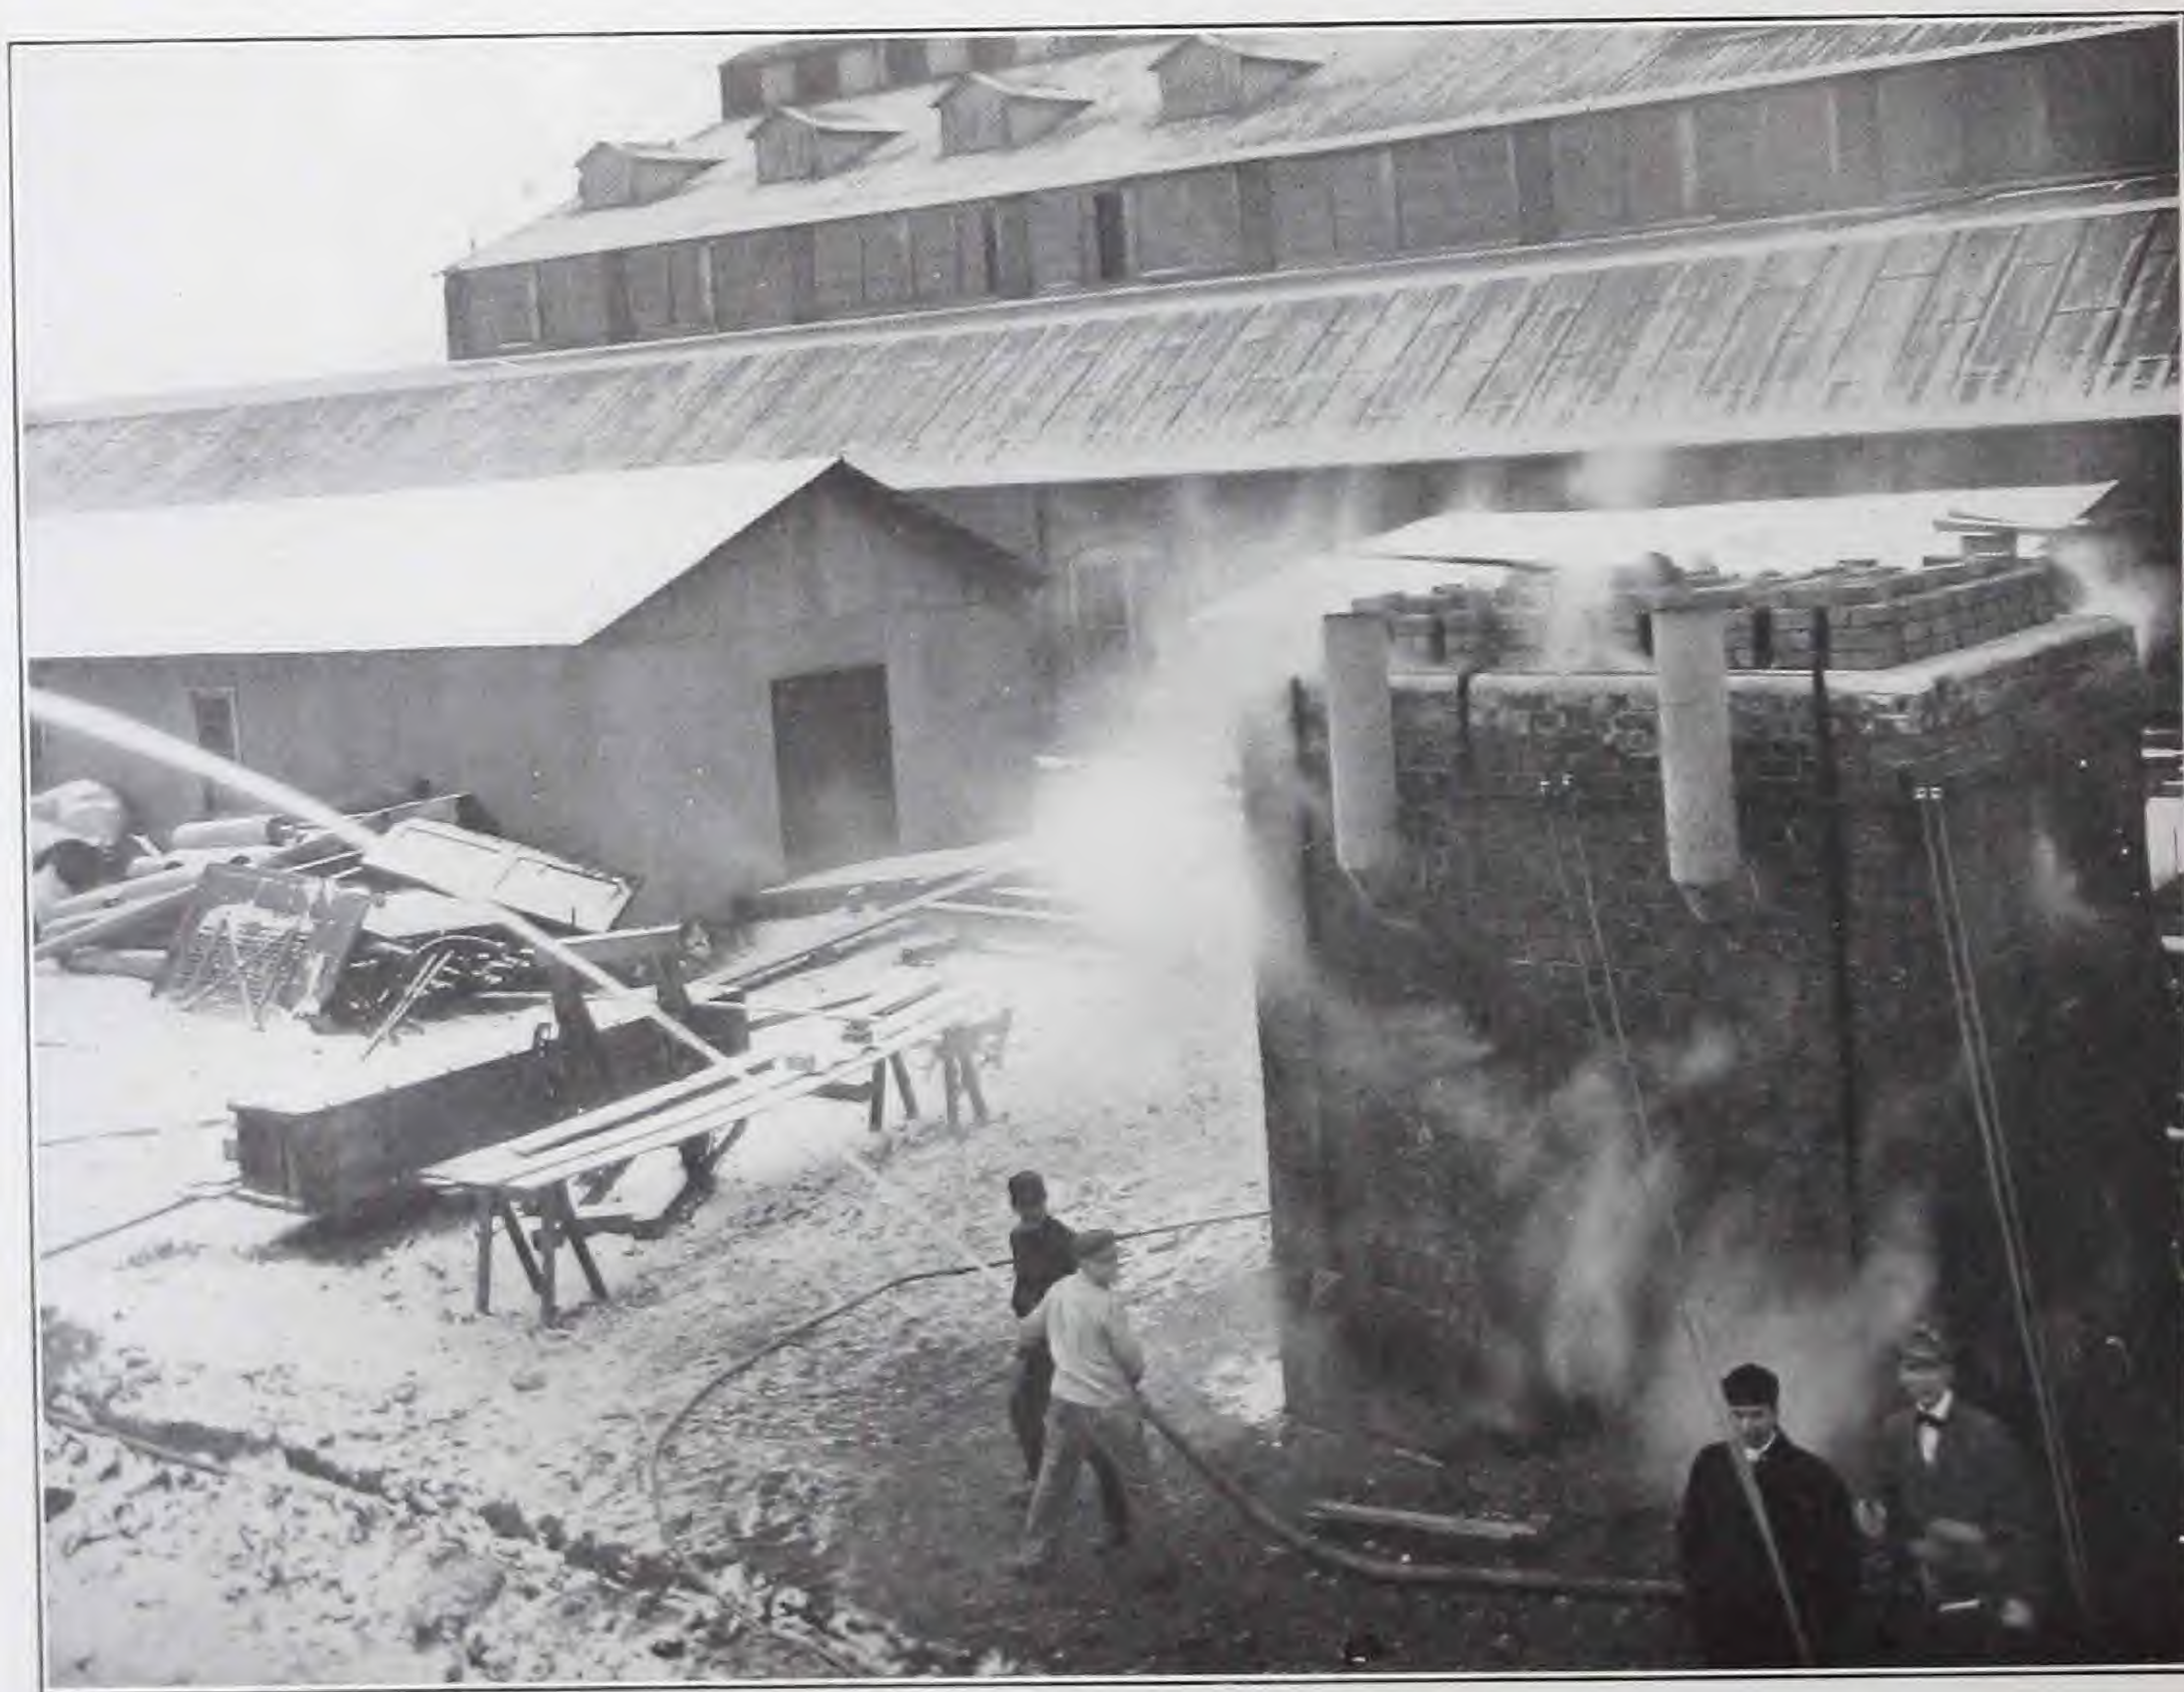
Testing the Water Pressure Before Same was Applied to Ceiling of Furnace After Latter Had Been Fired Four Hours and Ten Minutes. Temperature 1598° F.
